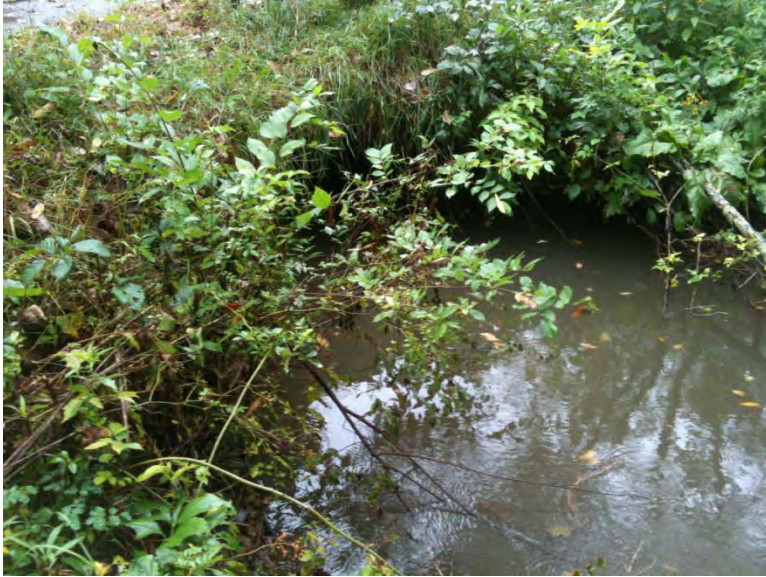
BLU1- DOWNSTREAM

Structure Shape: Ellipse
 Structure Material: Metal
 Substrate in Structure: Sand
 Structure Condition: General Condition: New Good Fair Poor
 Plugged: 0 % Inlet Outlet In Pipe
 Crushed: 0 % Inlet Outlet In Pipe
 Rusted Through? Yes No

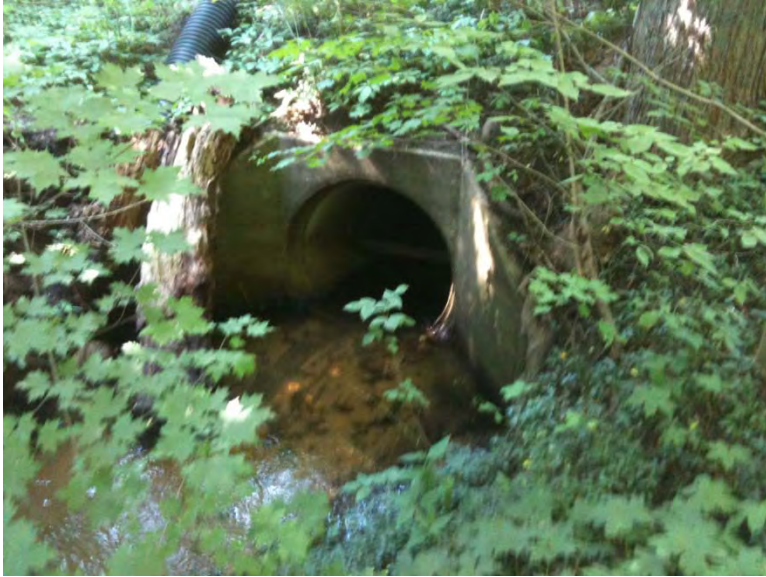
BLU10- DOWNSTREAM

Structure Shape	Structure Material	Substrate in Structure	Structure Condition
<u>Round</u>	Metal	None Sand	General Condition: New <u>Good</u> Fair Poor
Square/Rectangle	<u>Concrete</u>	Gravel Rock	Plugged: ___ % Inlet Outlet In Pipe
Open Bottom Square/Rectangle	Plastic	Mixture	Crushed: ___ % Inlet Outlet In Pipe
Pipe Arch	Wood		Rusted Through? Yes No

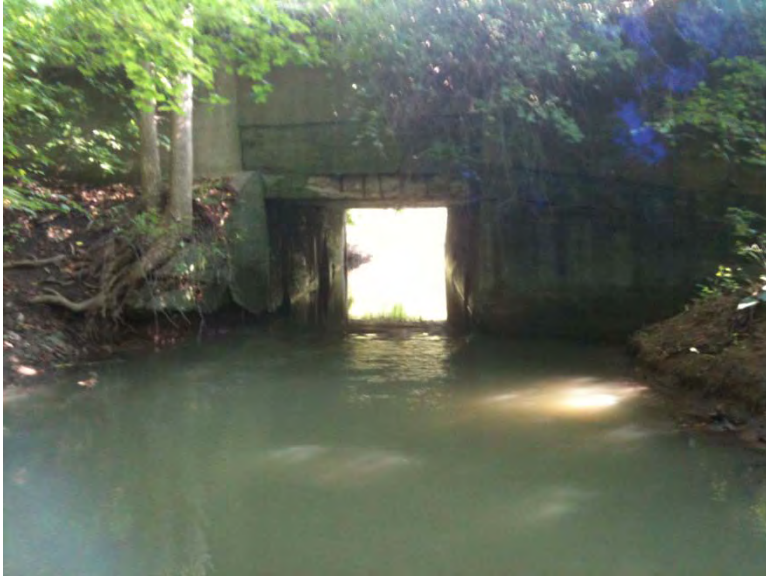
BLU5-DOWNSTREAM

Structure Shape	Structure Material	Substrate in Structure	Structure Condition
Round	Metal	None Sand	General Condition: New Good <u>Fair</u> Poor
Square/Rectangle	<u>Concrete</u>	Gravel Rock	Plugged: ___ % Inlet Outlet In Pipe
<u>Open Bottom Square/Rectangle</u>	Plastic	<u>Mixture</u>	Crushed: ___ % Inlet Outlet In Pipe
Pipe Arch	Wood		Rusted Through? Yes No

Turbid!

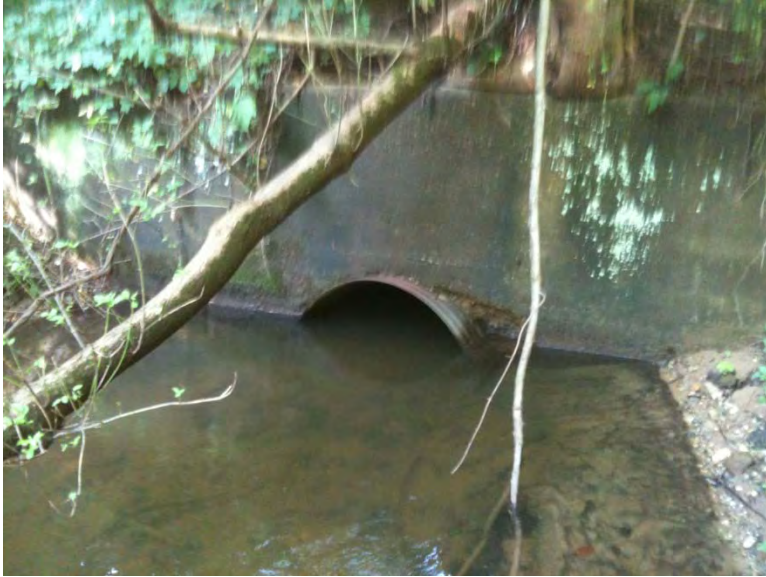
BLU6-DOWNSTREAM

Structure Shape	Structure Material	Substrate in Structure	Structure Condition
<u>Round</u>	<u>Metal</u>	None <u>Sand</u>	General Condition: New Good <u>Fair</u> Poor
Square/Rectangle	Concrete	Gravel Rock	Plugged: _____ % Inlet Outlet In Pipe
Open Bottom Square/Rectangle	Plastic	Mixture	Crushed: _____ % Inlet Outlet In Pipe
Pipe Arch	Wood		Rusted Through? Yes No

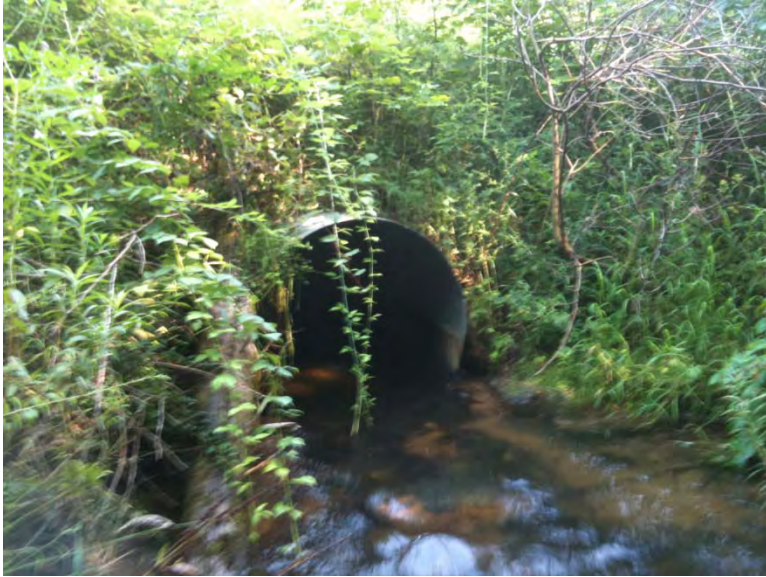
BLU7-DOWNSTREAM

Structure Shape	Structure Material	Substrate in Structure	Structure Condition
<u>Round</u>	<u>Metal</u>	None Sand	General Condition: New <u>Good</u> Fair Poor
Square/Rectangle	Concrete	Gravel Rock	Plugged: ___ % Inlet Outlet In Pipe
Open Bottom Square/Rectangle	Plastic	Mixture	Crushed: ___ % Inlet Outlet In Pipe
Pipe Arch	Wood		Rusted Through? Yes No

cold water - beautiful! 7.3 ft/sec @ inlet + slight drop

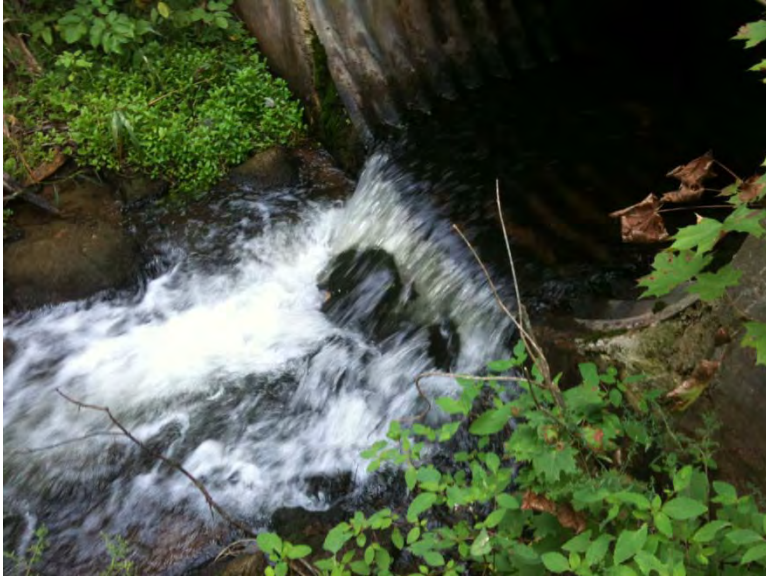
BLU9- DOWNSTREAM

Structure Shape: Round Structure Material: Metal Substrate in Structure: None Sand Gravel Rock Mixture Structure Condition: General Condition: New Good Fair Poor
Plugged: _____ % Inlet Outlet In Pipe
Crushed: _____ % Inlet Outlet In Pipe
Rusted Through? Yes No

perched at d/s - 2' nick pt at u/s

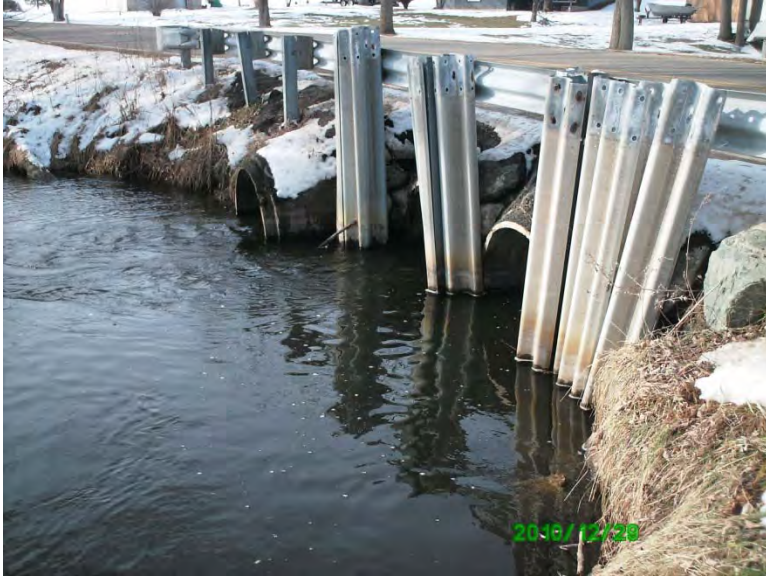
CHR17-DOWNSTREAM

Structure Shape	Structure Material	Substrate in Structure	Structure Condition
<u>Round</u>	Metal	None Sand	General Condition: New Good Fair <u>Poor</u>
Square/Rectangle	<u>Concrete</u>	Gravel Rock	Plugged: ___ % Inlet Outlet In Pipe
Open Bottom Square/Rectangle	Plastic	Mixture	Crushed: ___ % Inlet Outlet In Pipe
Pipe Arch	Wood		Rusted Through? Yes No

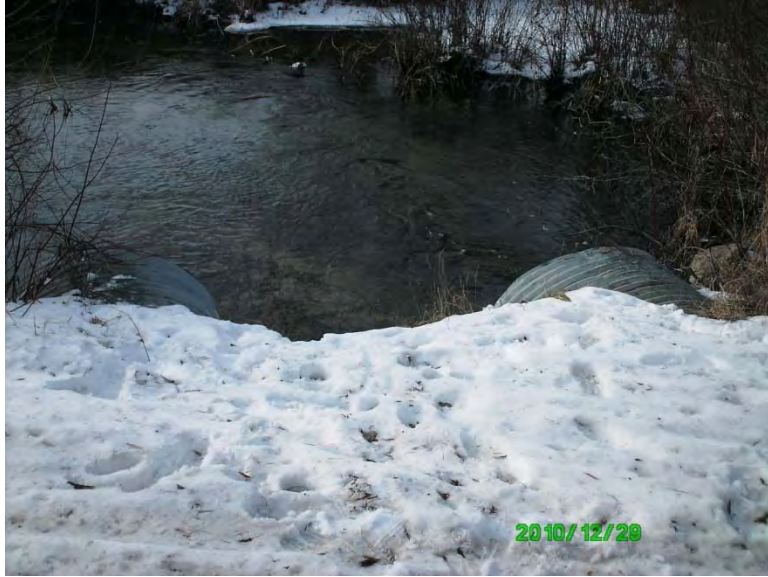
CHR18-PARADISE OUTLET

Structure Shape	Structure Material	Substrate in Structure	Structure Condition
Round	<u>Metal</u>	None Sand	General Condition: New Good Fair <u>Poor</u>
Square/Rectangle	Concrete	<u>Gravel</u> Rock	Plugged: _____ % Inlet Outlet In Pipe
Open Bottom Square/Rectangle	Plastic	<u>Mixture</u>	Crushed <u>20</u> % <u>Inlet</u> <u>Outlet</u> In Pipe
Pipe Arch	Wood		Rusted Through? Yes No

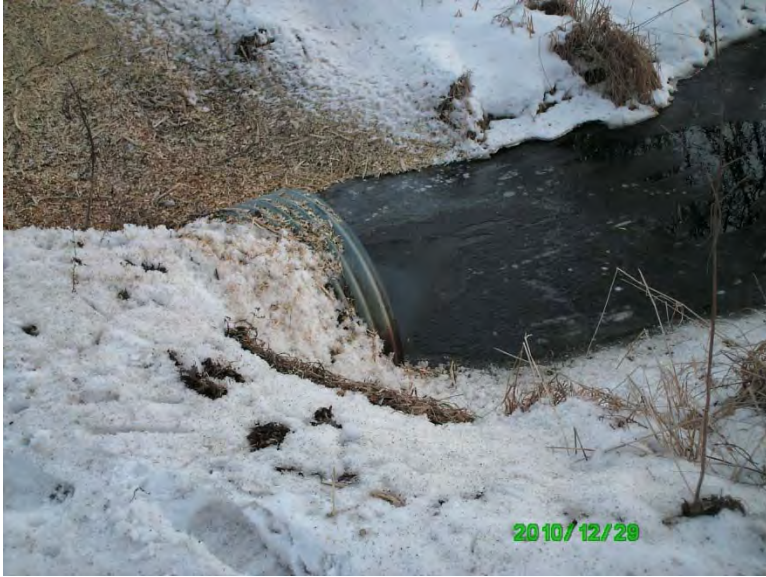
CHR22

No Resource Value

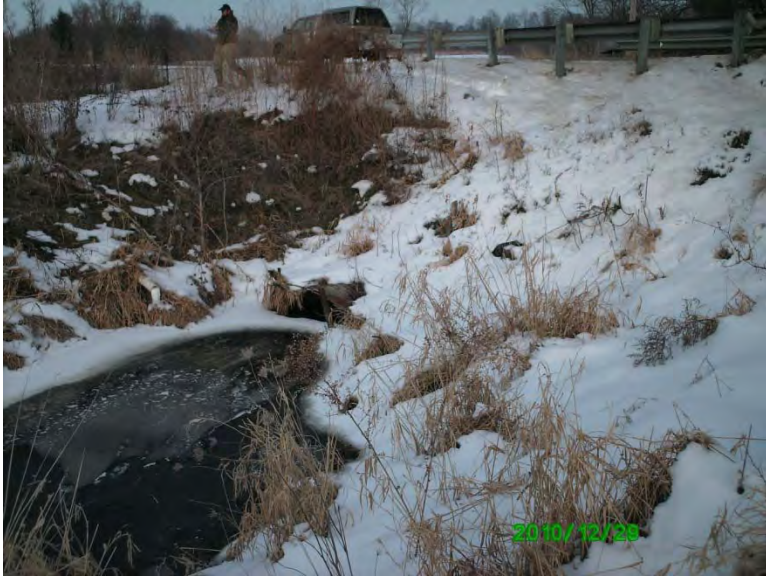
CHR23-LAKE OUTLET

Structure Shape	Structure Material	Substrate in Structure	Structure Condition
<u>Round</u>	<u>Metal</u>	None Sand	General Condition: New Good <u>Fair</u> Poor
Square/Rectangle	Concrete	Gravel Rock	Plugged: _____ % Inlet Outlet In Pipe
Open Bottom Square/Rectangle	Plastic	Mixture	Crushed: _____ % Inlet Outlet In Pipe
Pipe Arch	Wood		Rusted Through? Yes No

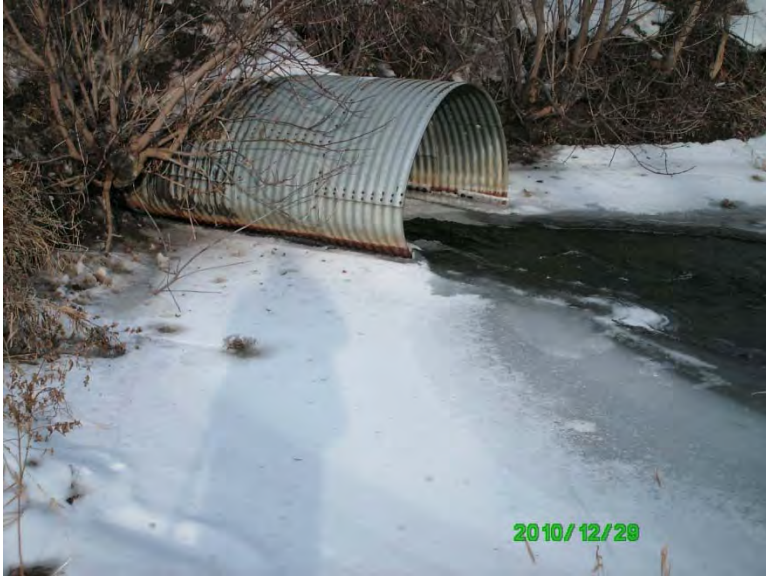
CHR24-Diamond Outlet

Structure Shape	Structure Material	Substrate in Structure	Structure Condition
Round	<u>Metal</u>	<u>None</u>	General Condition: New <u>Good</u> Fair Poor
Square/Rectangle	Concrete	Gravel	Plugged: _____ % Inlet Outlet In Pipe
Open Bottom Square/Rectangle	Plastic	Mixture	Crushed: _____ % Inlet Outlet In Pipe
Pipe Arch	Wood		Rusted Through? Yes No

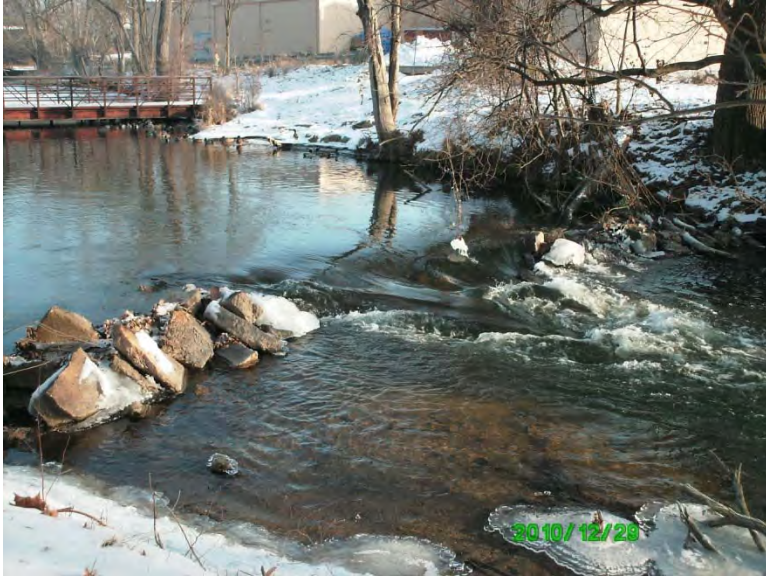
CHR3

- Physical Condition Ranking: (Please Rank - 5 being best condition, 1 being worst): 5, 4, 3, ② 1
Reasoning/Justification:
- Does the dam have the ability to regulate water level? Y N
- Is it being actively managed? Y N
- Based on MDNRE contamination flowchart (included in instructions), should sediments be tested?
- Is another barrier (dam or road crossing) visible up or downstream? Y N
- Are there any invasive species present? Y N If so, which? _____
