Stream Crossing Data Sheet

Site ID: FAWN 13

Road Name/Number: Alarion Lk Rd

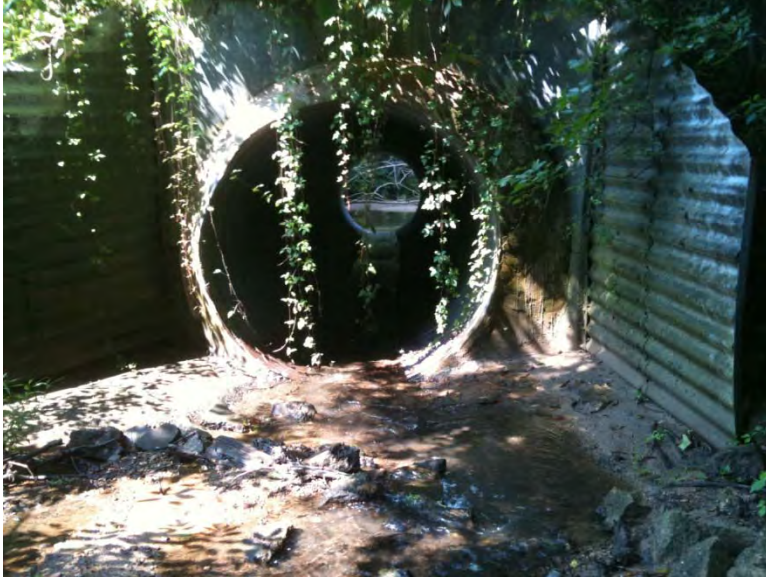
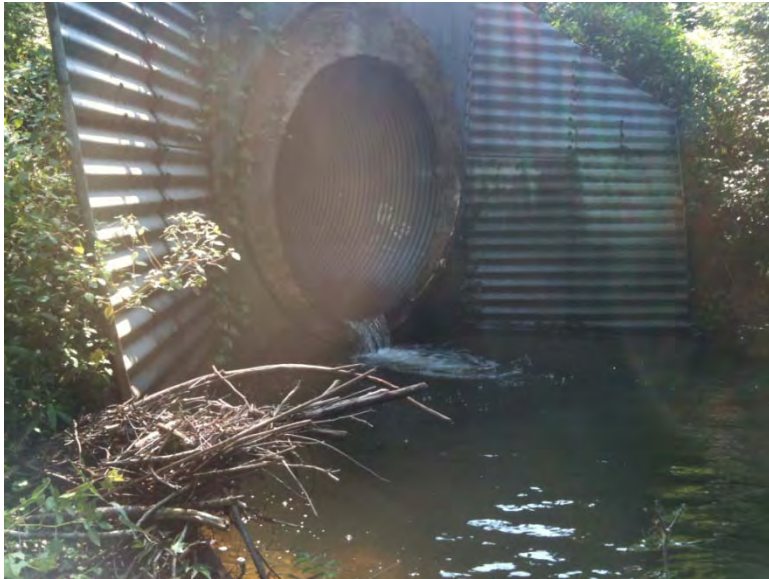
LCN1- UPSTREAM

3" steps in culvert - 0.2' deep cold water. Lots of fish in & near pool. white substrate, silt/moss, etc.

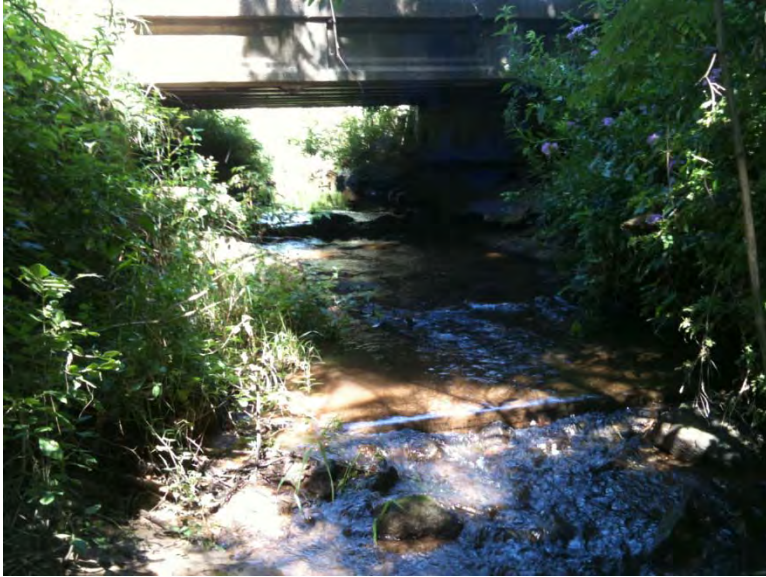
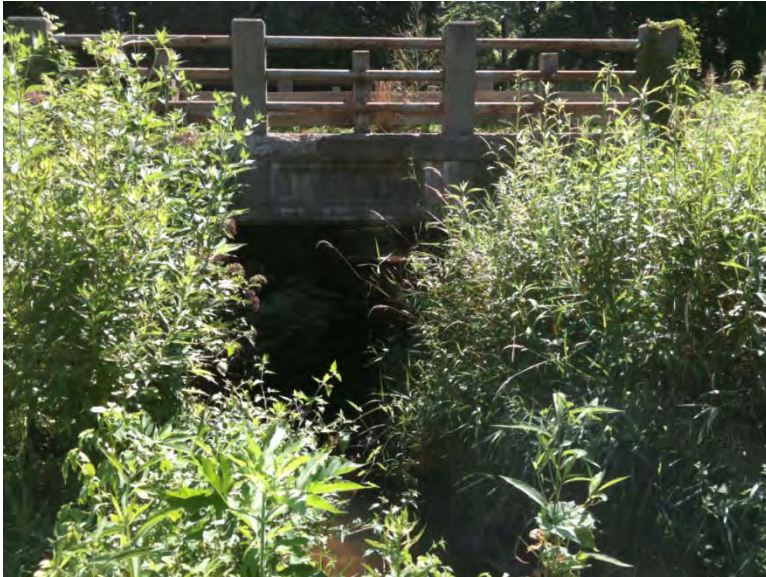
LMN4- DOWNSTREAM

Structure Interior: Smooth or Corrugated *Broken concrete*

low-flow channel built in culvert to stabilize headwalls. small dam built in culvert. Agron on old road - previous attempt at fish passage?

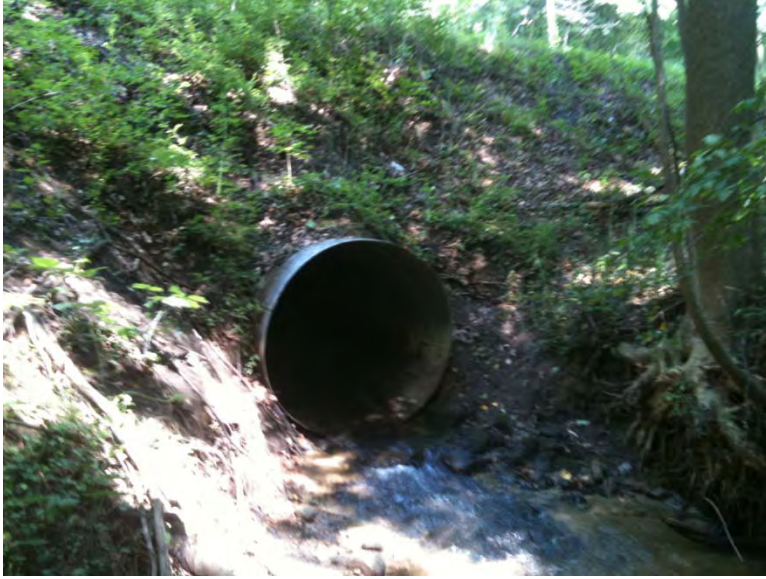
PIP6-DOWNSTREAM

large sediment load, severe/high bank erosion
