Site ID: Adams Dam

St. Joseph Watershed Dam Inventory Data Form

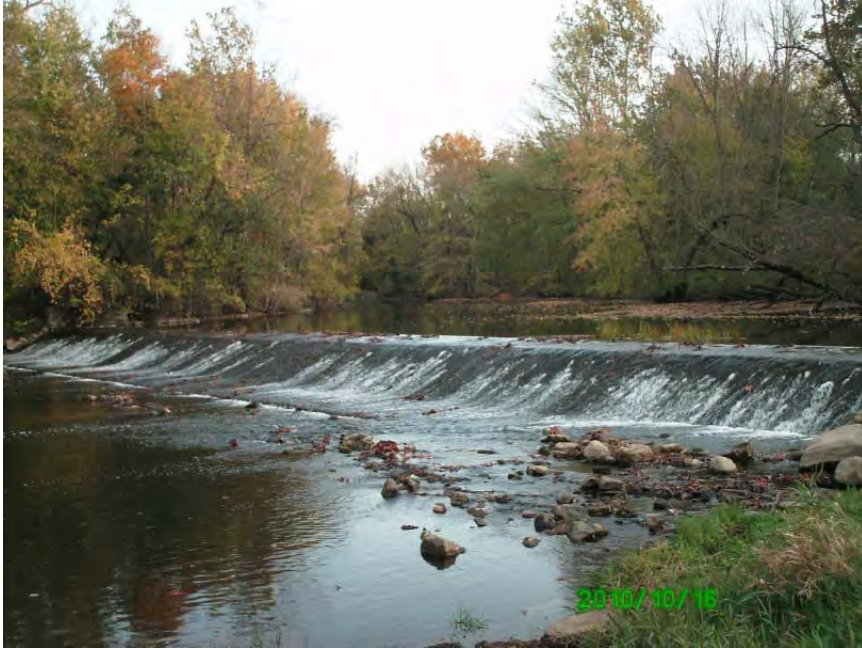
BAINTER TOWN DAM

- Physical Condition Ranking: (Please Rank - 5 being best condition, 1 being worst): 5, 4, (3), 2, 1
Reasoning/Justification: Old dam no longer maintained
- Does the dam have the ability to regulate water level? Y N
- Is it being actively managed? Y N
- Based on MDNRE contamination flowchart (included in instructions), should sediments be tested? No
- Is another barrier (dam or road crossing) visible up or downstream? Y N
- Are there any invasive species present? Y N If so, which? Possibly common carp

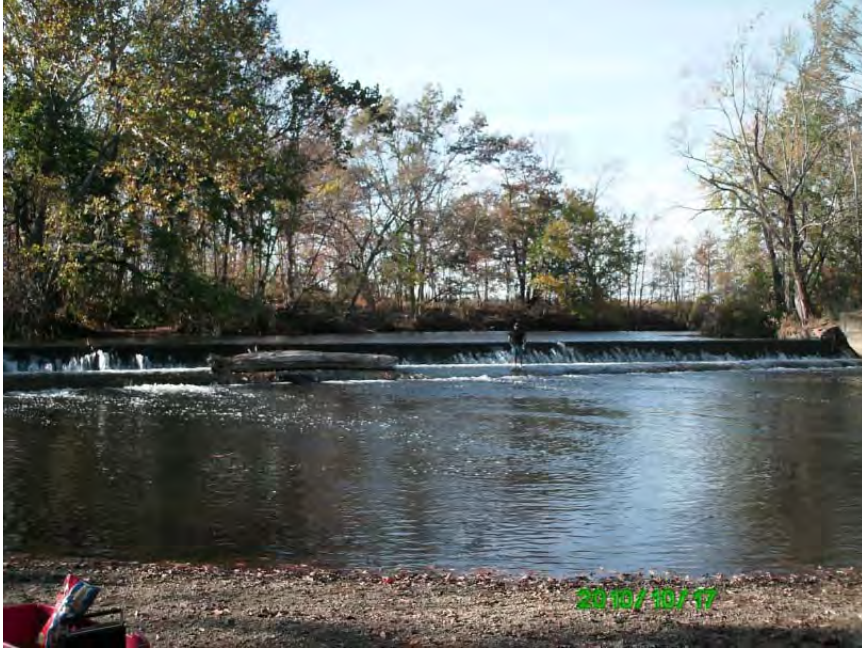
BENTON DAM

- Physical Condition Ranking: (Please Rank - 5 being best condition, 1 being worst): 5, 4, 3, 2, 1
Reasoning/Justification: Old dam no longer maintained
- Does the dam have the ability to regulate water level? Y N
- Is it being actively managed? Y N
- Based on MDNRE contamination flowchart (included in instructions), should sediments be tested? No
- Is another barrier (dam or road crossing) visible up or downstream? Y N
- Are there any invasive species present? Y N If so, which? Common carp

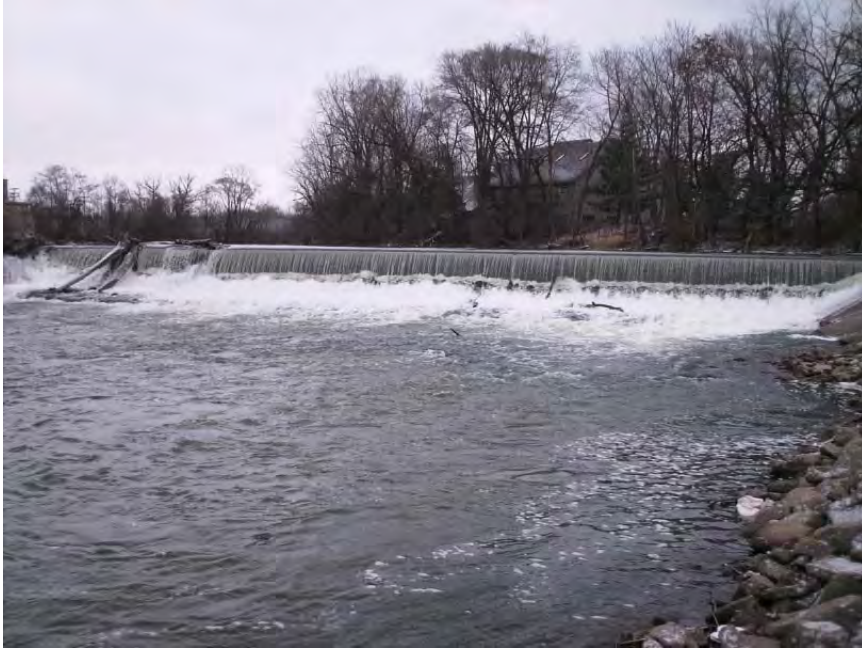
DOWNSTREAM ELKHART RIVER DAM

- Physical Condition Ranking: (Please Rank - 5 being best condition, 1 being worst): 5, 4, (3) 2, 1
Reasoning/Justification: *old dam*
- Does the dam have the ability to regulate water level? Y N
- Is it being actively managed? Y N
- Based on MDNRE contamination flowchart (included in instructions), should sediments be tested? *Yes*
- Is another barrier (dam or road crossing) visible up or downstream? Y N *road crossing*
- Are there any invasive species present? Y N If so, which? *Grizzard shad, common carp*

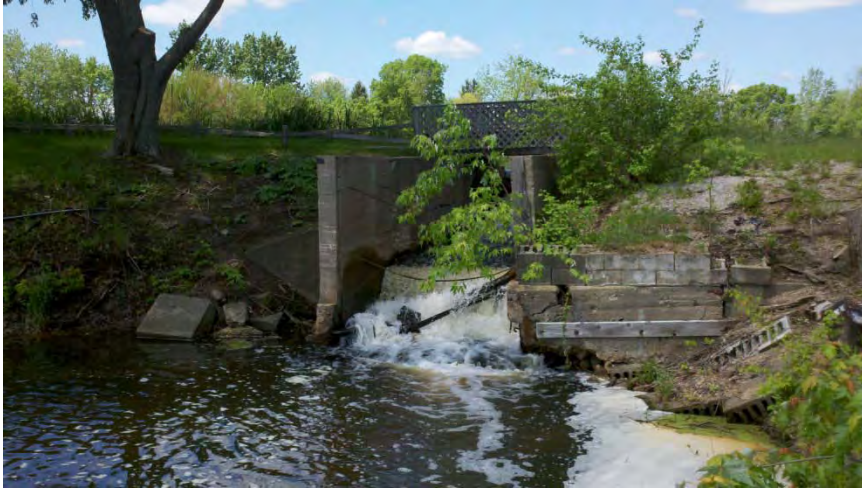
DOWNSTREAM OF FOX AND BEARS DAM

- Physical Condition Ranking: (Please Rank - 5 being best condition, 1 being worst): 5, 4, 3, 2
Reasoning/Justification: crumbling concrete - seepage on n/s side (piping)
- Does the dam have the ability to regulate water level? Y N
- Is it being actively managed? Y N
- Based on MDNRE contamination flowchart (included in instructions), should sediments be tested?
- Is another barrier (dam or road crossing) visible up or downstream? Y N
- Are there any invasive species present? Y N If so, which? _____

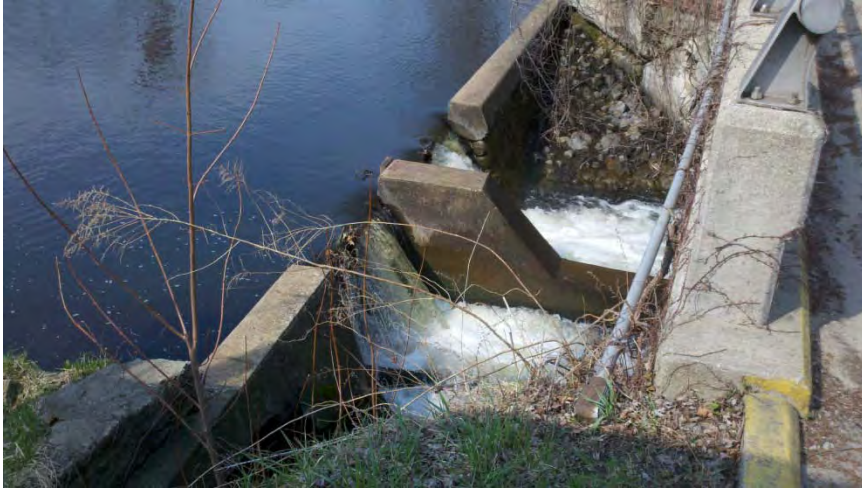
MCCOY DAM

- Physical Condition Ranking: (Please Rank - 5 being best condition, 1 being worst): 5, 4, 3, 2, 1
Reasoning/Justification: cracked concrete water leaking @ bottom of spillway
- Does the dam have the ability to regulate water level? Y N
- Is it being actively managed? Y N
- Based on MDNRE contamination flowchart (included in instructions), should sediments be tested? No!
- Is another barrier (dam or road crossing) visible up or downstream? Y N
- Are there any invasive species present? Y N If so, which? Open to site

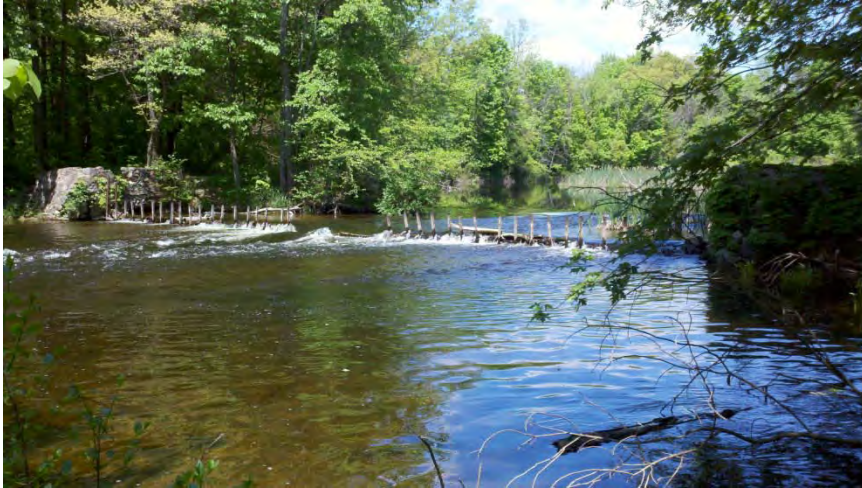
PARKVILLE DAM

- Physical Condition Ranking: (Please Rank - 5 being best condition, 1 being worst): 5, 4, 3, 2, ①
- Reasoning/Justification:
- Does the dam have the ability to regulate water level? Y N
- Is it being actively managed? Y N
- Based on MDNRE contamination flowchart (included in instructions), should sediments be tested?
- Is another barrier (dam or road crossing) visible up or downstream? Y N
- Are there any invasive species present? Y N If so, which? _____

* High priority for improvement

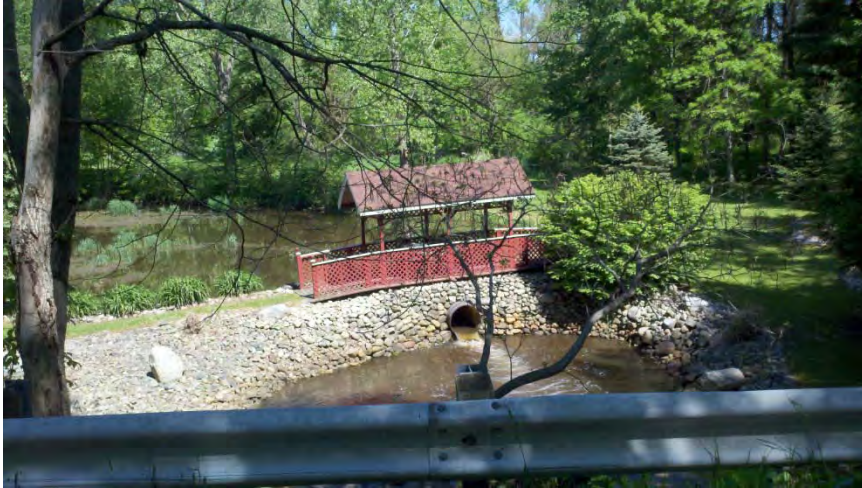
POLLOCK DAM

- Physical Condition Ranking: (Please Rank - 5 being best condition, 1 being worst): 5, 4, 3, 2, 1
Reasoning/Justification:
- Does the dam have the ability to regulate water level? Y N
- Is it being actively managed? Y N *drawdown during visit?*
- Based on MDNRE contamination flowchart (included in instructions), should sediments be tested?
- Is another barrier (dam or road crossing) visible up or downstream? Y N
- Are there any invasive species present? Y N If so, which? _____

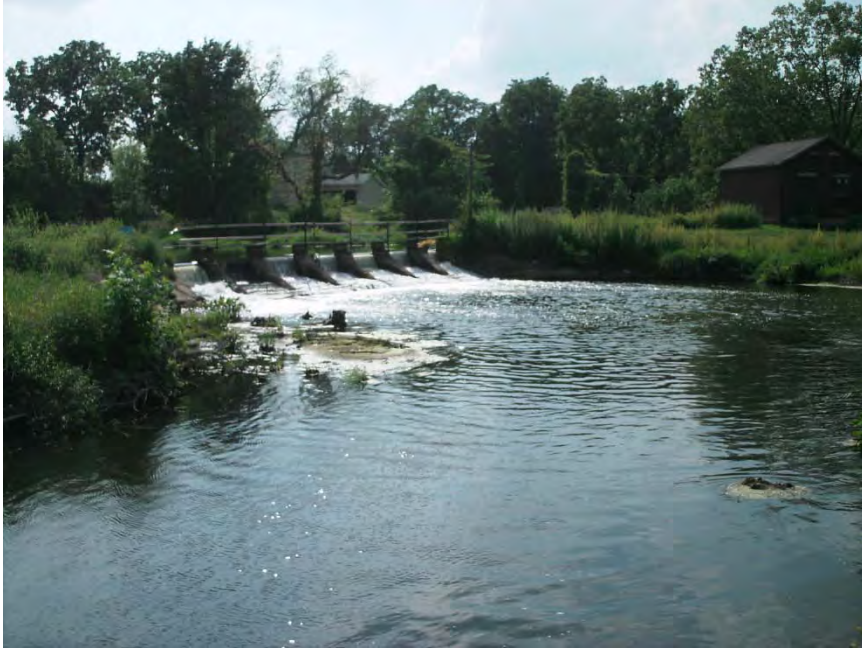
DOWNSTREAM OF STAR MILLING DAM

- Physical Condition Ranking: (Please Rank - 5 being best condition, 1 being worst): 5, 4, 3, 2, 1
Reasoning/Justification: Old dam, lack of maintenance
- Does the dam have the ability to regulate water level? Y N
- Is it being actively managed? Y N
- Based on MDNRE contamination flowchart (included in instructions), should sediments be tested? Not sure
- Is another barrier (dam or road crossing) visible up or downstream? Y N stream crossing
- Are there any invasive species present? Y N If so, which? Purple loosestrife
