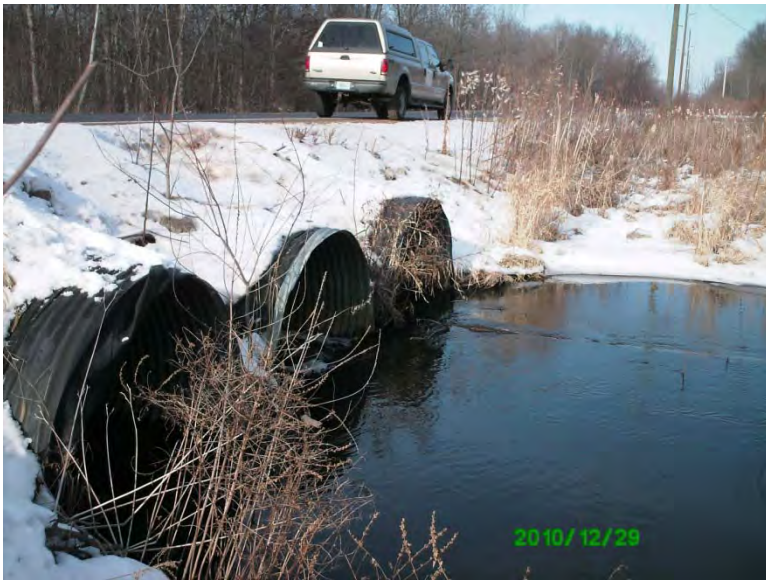
CHR16-DOWNSTREAM

Structure Shape	Structure Material	Substrate in Structure	Structure Condition
<u>Round</u>	Metal	None Sand	General Condition: New Good Fair <u>Poor</u>
Square/Rectangle	<u>Concrete</u>	Gravel Rock	Plugged: ___ % Inlet Outlet In Pipe
Open Bottom Square/Rectangle	Plastic	Mixture	Crushed: ___ % Inlet Outlet In Pipe
Pipe Arch	Wood		Rusted Through? Yes No

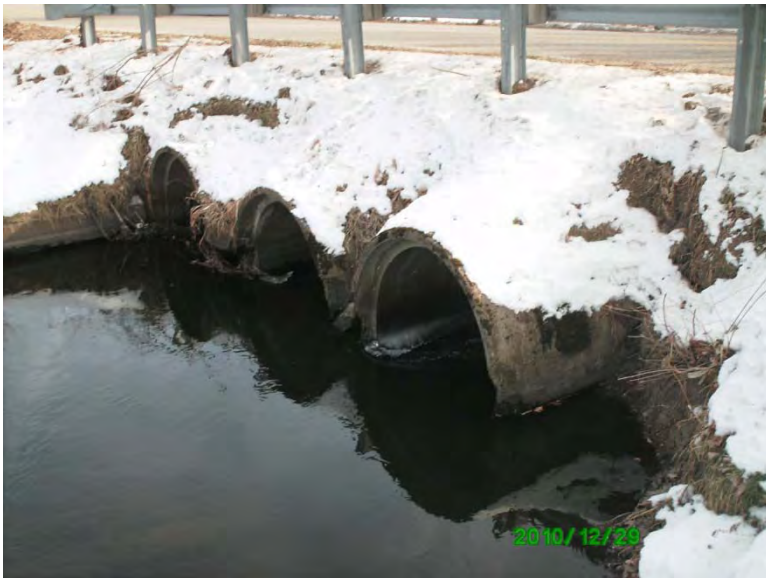
CHR17-DOWNSTREAM

Structure Shape	Structure Material	Substrate in Structure	Structure Condition
Round	<u>Metal</u>	None Sand	General Condition: New Good Fair <u>Poor</u>
Square/Rectangle	Concrete	<u>Gravel</u> Rock	Plugged: _____ % Inlet Outlet In Pipe
Open Bottom Square/Rectangle	Plastic	<u>Mixture</u>	Crushed <u>20</u> % <u>Inlet</u> <u>Outlet</u> In Pipe
Pipe Arch	Wood		Rusted Through? Yes No

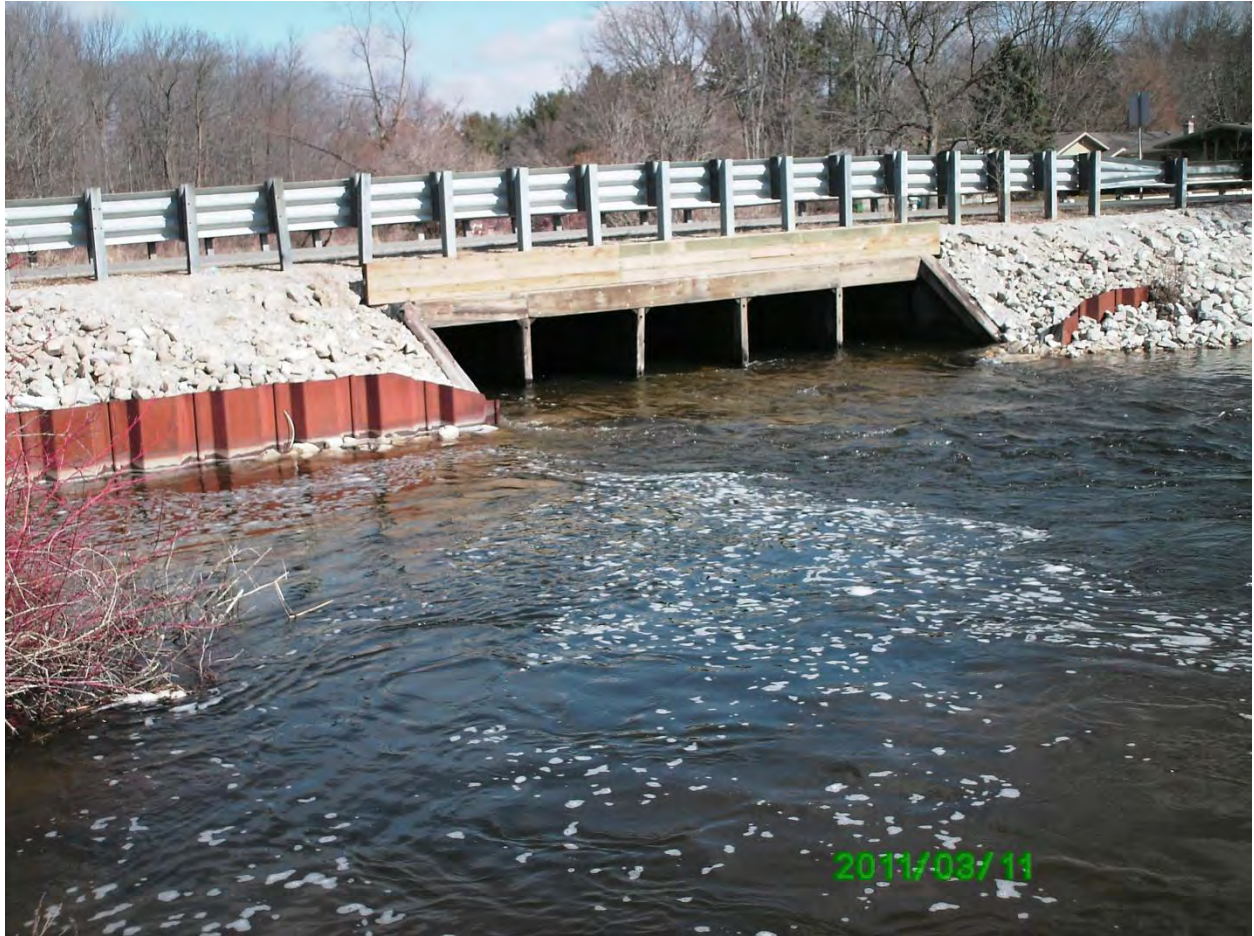
CHR29-Redfield Road

A Stream Crossing Data Sheet was not provided for this site during the 2011 field inspection.
- Streamside Ecological Services
