Stream Crossing Data Sheet

Site ID: FAWN 13

Road Name/Number: Alarion Lk Rd

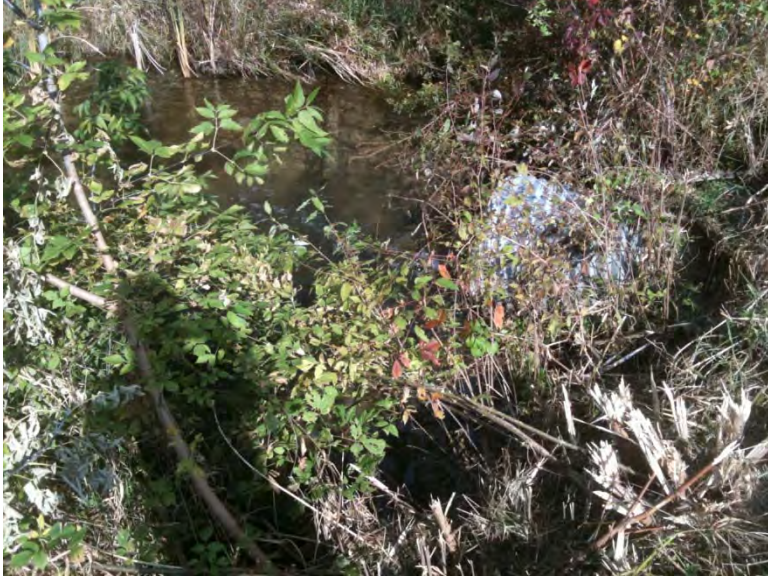
FAWN13

Structure Shape	Structure Material	Substrate in Structure	Structure Condition
<u>Round</u>	<u>Metal</u>	None Sand	General Condition: New Good Fair Poor
Square/Rectangle	Concrete	Gravel Rock	Plugged: <u>50</u> % Inlet Outlet In Pipe
Open Bottom Square/Rectangle	Plastic	Mixture	Crushed _____ % Inlet Outlet In Pipe
Pipe Arch	Wood		Rusted Through? Yes No

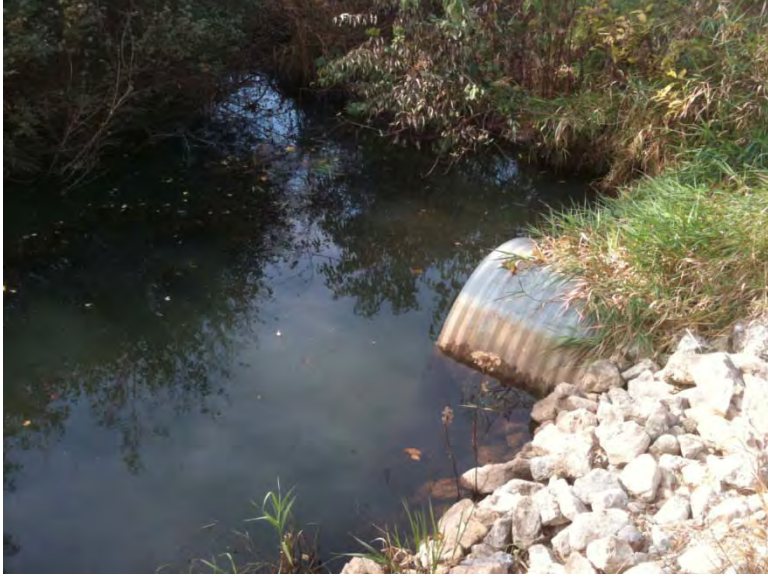
FAWN16-CULVERT

Structure Shape	Structure Material	Substrate in Structure	Structure Condition
<u>Round</u>	<u>Metal</u>	None Sand	General Condition: New <u>Good</u> Fair Poor
Square/Rectangle	Concrete	Gravel Rock	Plugged: <u>5</u> % Inlet Outlet In Pipe
Open Bottom Square/Rectangle	Plastic	Mixture	Crushed: <u>5</u> % Inlet Outlet In Pipe
Pipe Arch	Wood		Rusted Through? Yes No

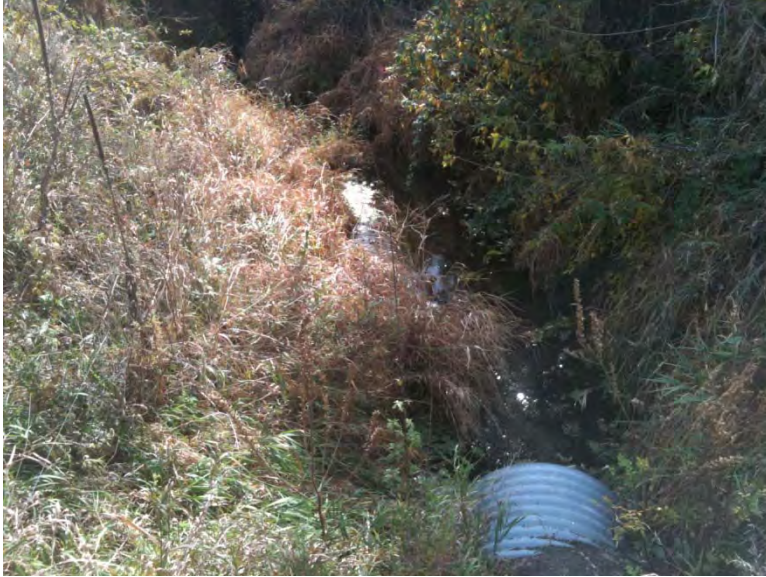
FAWN17-CULVERT

Structure Shape	Structure Material	Substrate in Structure	Structure Condition
<u>Round</u>	<u>Metal</u>	None <u>Sand</u>	General Condition: New Good Fair Poor
Square/Rectangle	Concrete	Gravel Rock	Plugged: _____ % Inlet Outlet In Pipe
Open Bottom Square/Rectangle	Plastic	Mixture	Crushed: _____ % Inlet Outlet In Pipe
Pipe Arch	Wood		Rusted Through? Yes No

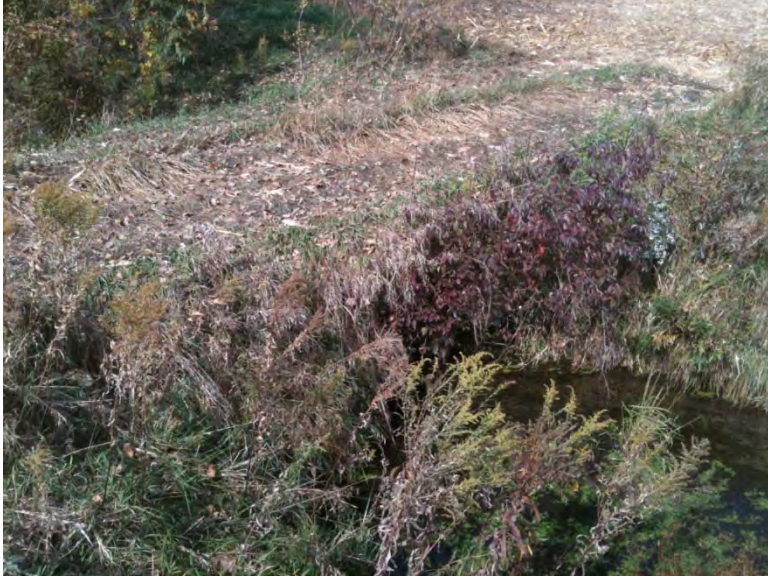
FAWN18

Structure Shape	Structure Material	Substrate in Structure	Structure Condition
Round	Metal	None	<u>Sand</u>
Square/Rectangle	<u>Concrete</u>	<u>Gravel</u>	Rock
<u>Open Bottom Square/Rectangle</u>	Plastic	<u>Mixture</u>	
Pipe Arch	Wood		
Open Bottom Arch			
Ellipse
